AS 2013.36 - 14/02/2013

Examination of CRV « Cliffbot » Sciencecam videos from tests 97 to 100

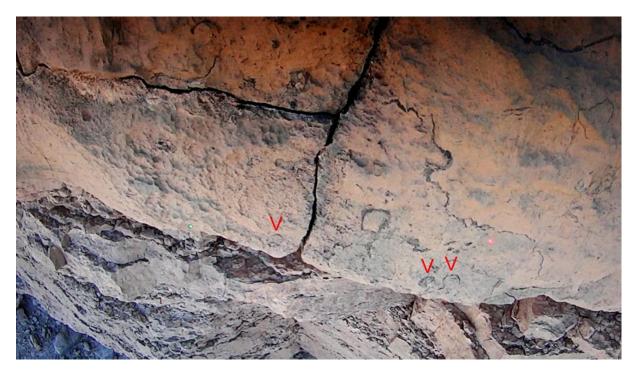
Time 3.16: possible indication of fossils (circular shapes); the two laser spots, green on the left and red on the right are visible. Their distance is 22,5 cm thus the circular shapes are 1.2 cm in diameter.

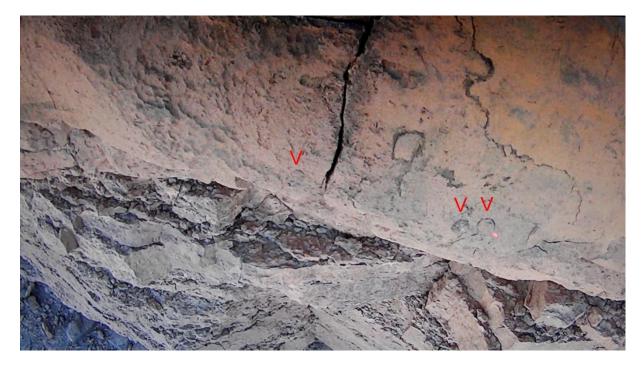
Time 3.17: same area; the green laser is no more visible, being hidden under the overhang.

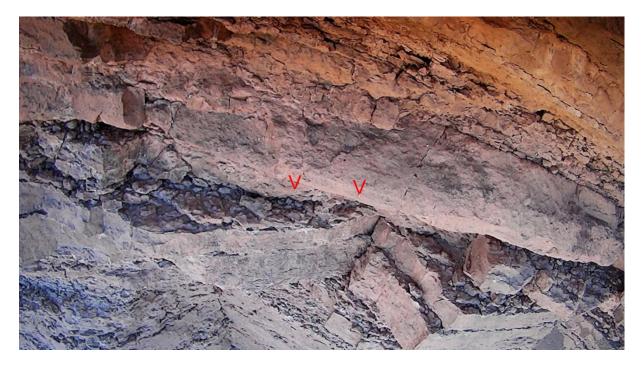
Time 3.23: the two lasers spots are visible and seem close to each other; it means the vehicle is far from the wall under an overhang. Calculation gives around 70 cm for the overhang knowing that the field of view is 120°.

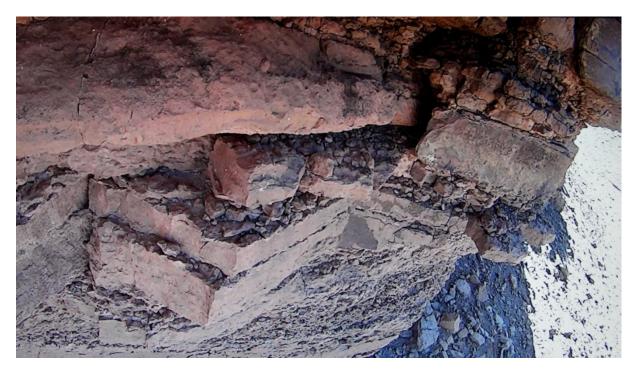
Time 3.29: rotation of the vehicle to the right showing the side of the cliff. The cliff seems to be an alternation of hard limestone and softer layers of clays mixed with small rocks.

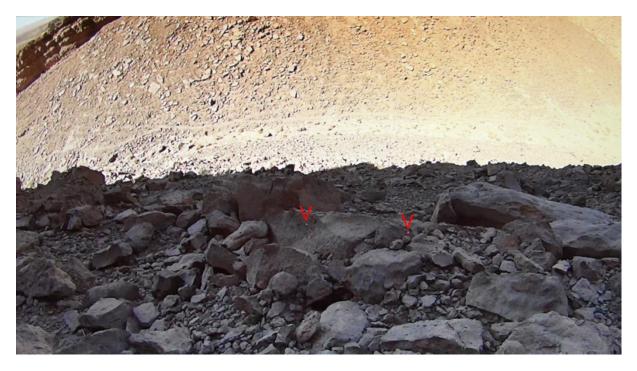
Time 6.05: "the cliffbot has landed". The two laser spots are visible. The video shows that the vehicle has rotated by $2x360^{\circ} + 180^{\circ}$ on the right before reaching the ground. This indicates an overhang of more than 1.3 m otherwise the antiroll rods would have stopped the rotation. The Sciencecam is now facing down slope instead of facing up slope.

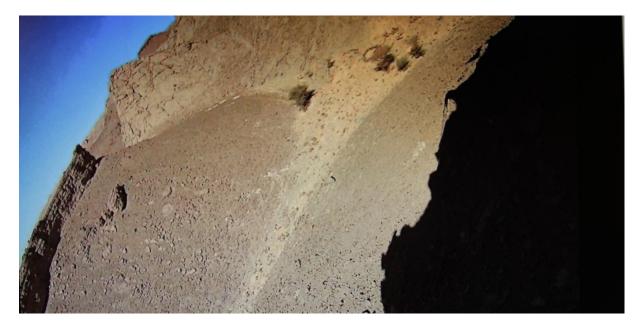
Time 14.39: view opposite to the cliff showing one of the mud volcanoes. The vehicle is canted 60° to the right indicating a difficulty for one wheel to get up the overhang.

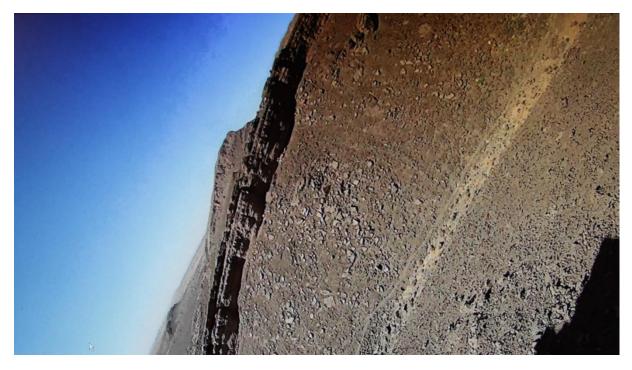
Time 14.46 : vehicle still strongly inclined (70°)

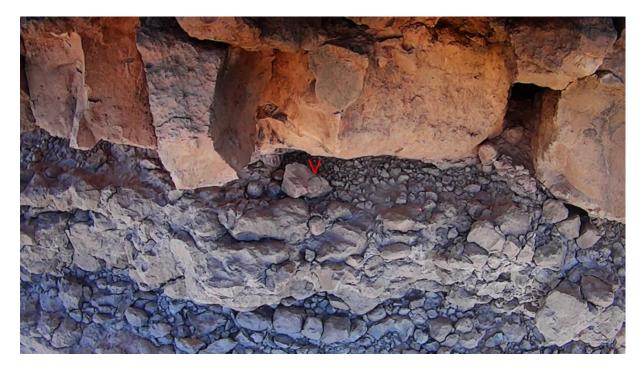
Time 1.14: indication of fossil (circular shape); the green laser is not operating on this run.

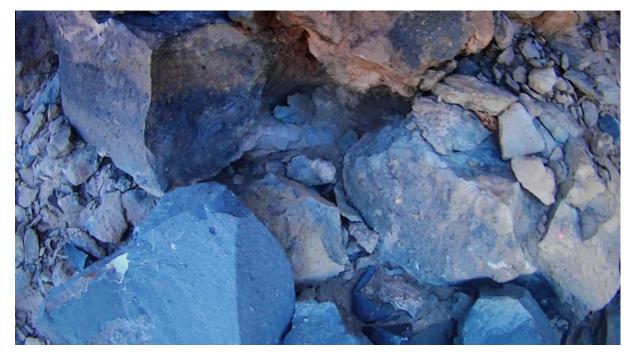
Time 2.47: strange area of blue rocks! This area is at the bottom of the cliff.

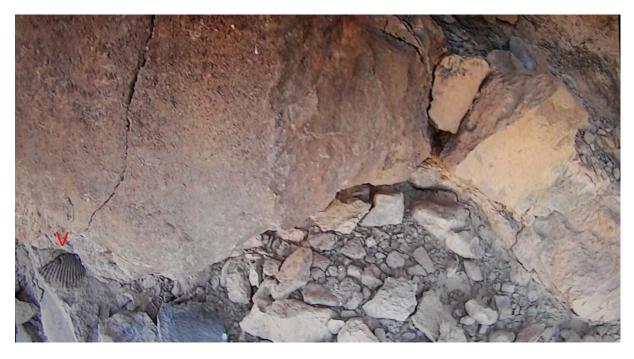
Time 7.56: well identified fossil on the left

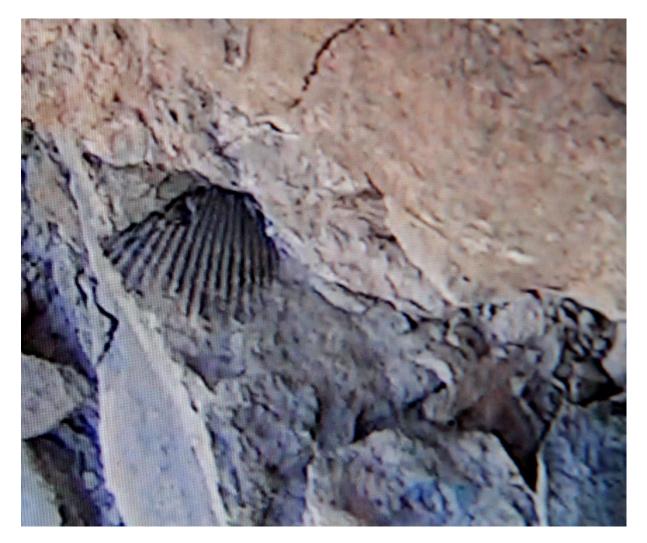
Time 7.56: zoom on the fossil.

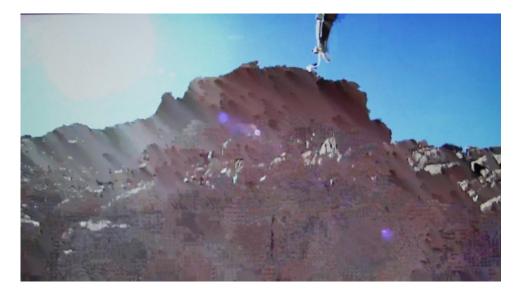
Time 2.50b: in a strong rocking motion of the platform the camera sees the rope and the operator up the cliff.

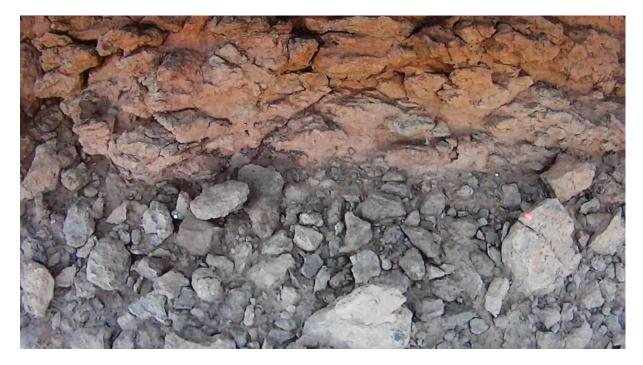
Time 8.53: the green laser is now operating during some seconds.

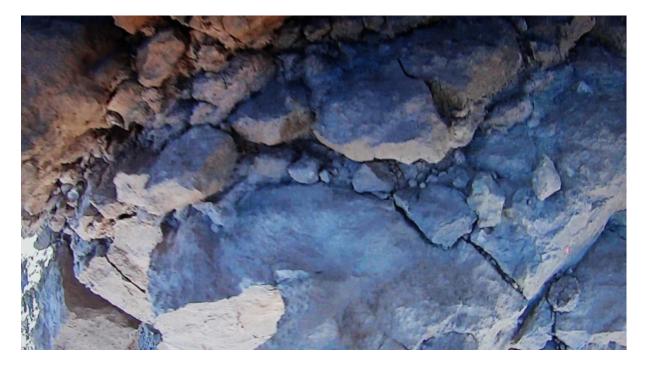
Time 9.27: the cliffbot is brought back up the hill and crosses an area of blue rocks which, in this part of the cliff, seems now at mid level and not down the hill like seen in the preceding test. This blue area is barely visible on the way down.

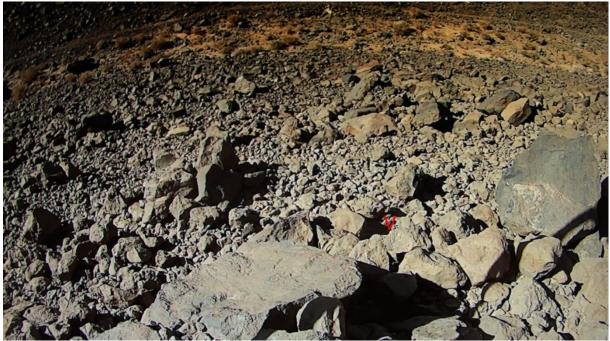
Time 1.44: the vehicle is rotated 180 ° with the Sciencecam looking down the hill; possible fossil in the middle right. The stone in the forefront middle seems also to present indications of fossils.
